Report Date 5/10/2007

Company G-MAN INSPECTION SERVICES, LLC
Address 4811 Corkwood Lane Orlando, FL 32808
Thermographer Carlos Guzman

Customer Sample
Site Address 123 MainUSA
Contact Person John Doe

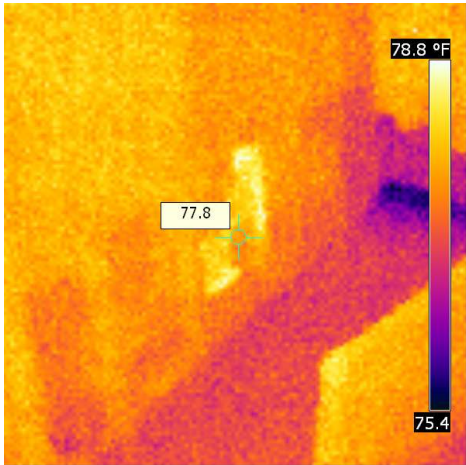
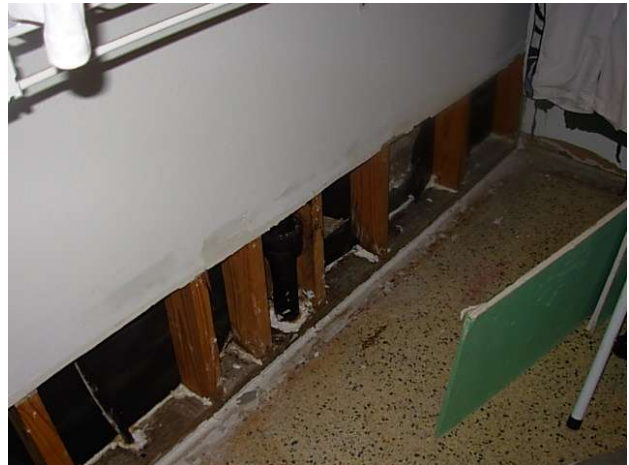
IR image: back of tile shower area (drywall removed for clarity). Shower was active with hot water (10 min. test). It appears that the grout/aggregate and liner has failed, allowing the heat to reflect on surface thus potential cause for leaks.

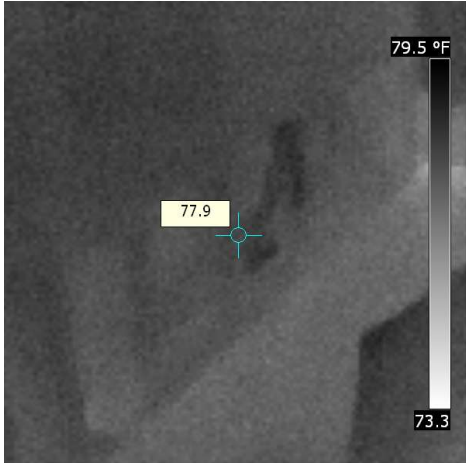
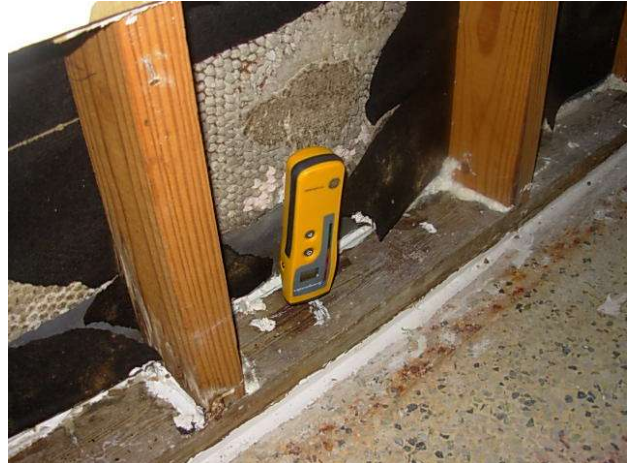
Description
How shower test. Moisture meter used to validate moisture findings. Replacement of shower enclosure recommended

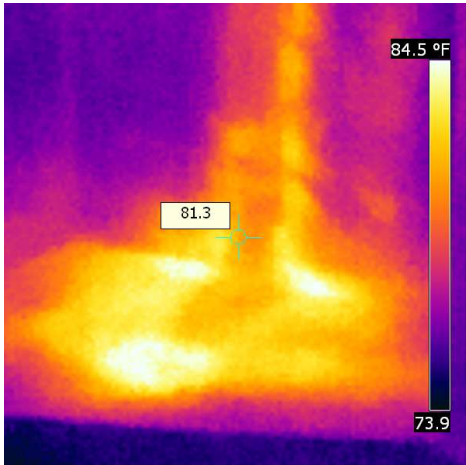
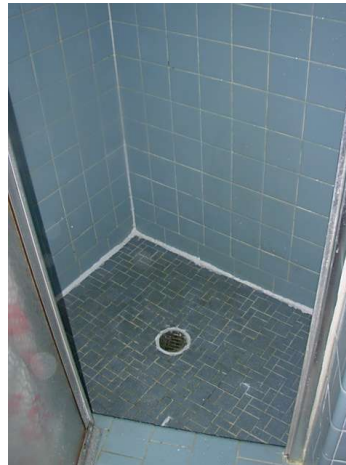
Description
stand up , tile shower. Hot water test (10 min)
