**Report Date** 4/11/2007

**Company** G-MAN INSPECTION SERVICES, LLC  
**Address** 4811 Corkwood Lane Orlando, FL 32808  
**Thermographer** Carlos Guzman

**Customer** Sample  
**Site Address** 123 MainUSA  
**Contact Person** John Doe

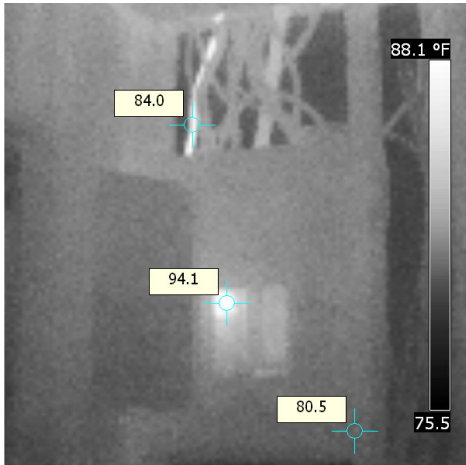
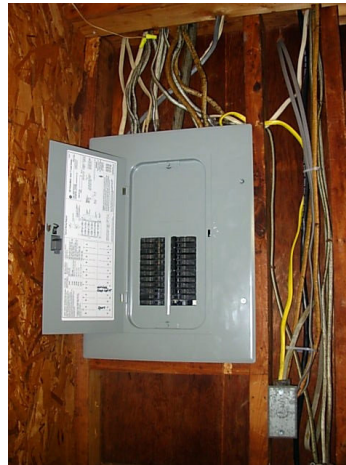
Image and Object Parameters		Text Comments
Camera Model	FLIR B-CAM Western S	
Image Date	2007:04:11 22:25:55	
Image Name	Electrical Sub-Panel.jpg	
Emissivity	0.92	
Reflected Temperature	72.0 °F	
Object Distance	6.6 ft

Description
Electrical sub-panel. 30A circuit breaker to water heater. Picture shows abnormal conditions in circuit (Hot breaker) by direct measurement. Unable to remove sub-panel cover at time of measurement. Recommend further evaluation by a licensed contractor.
