Report Date 5/10/2007

Company G-MAN INSPECTION SERVICES, LLC
Address 4811 Corkwood Lane Orlando, FL 32808
Thermographer Carlos Guzman

Customer Sample
Site Address 123 MainUSA
Contact Person John Doe

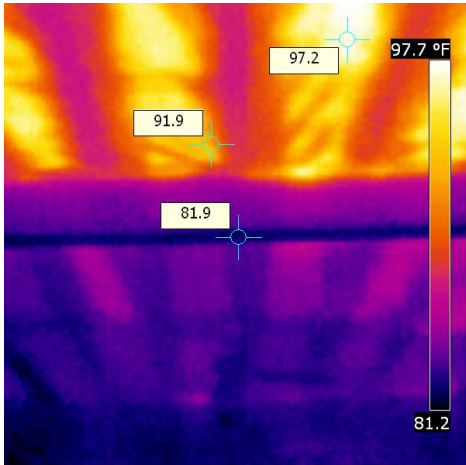
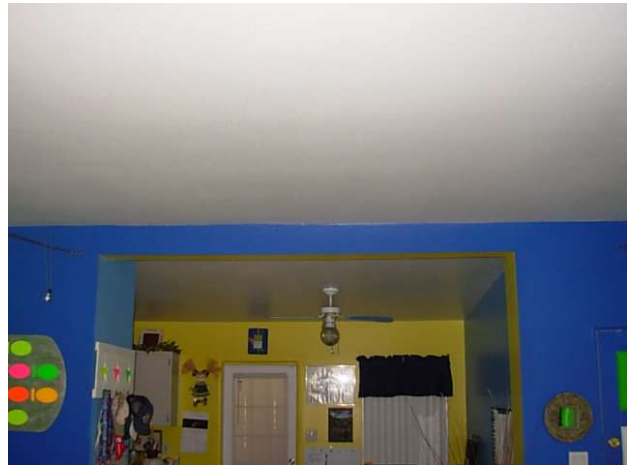
Image and Object Parameters		Text Comments
Camera Model	FLIR B-CAM Western S	
Image Date	2007:05:10 08:49:47	
Image Name	IR_0064.jpg	
Emissivity	0.95	
Reflected Temperature	78.0 °F	
Object Distance	8.0 ft

Description
TEST Image: 1959 house, livingroom ceiling surface. Image shows poor and compressed insulation coverage. Temp. measurements are approximate.
